Manhole Inspection Summary

Manhole # S13E1_002MH

Insp Date: **12/22/08 10:05 AM**

Location Address: **1620 S.Ellamont St.**

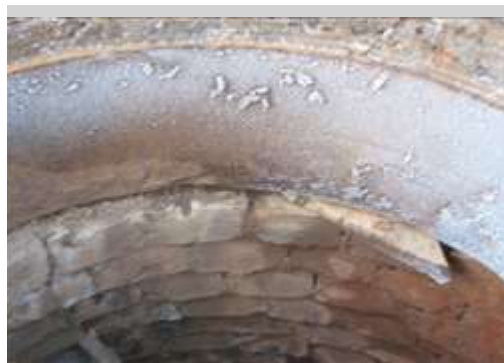
Defect 5

Chimney / Frame Adjustment ☒ Exists Material: **Brick** ☐ Parged Height: **3** (in.)

Condition: ☐ Sound ☒ **Cracked** ☐ Root Intrusion ☐ Loose Brick ☐ Deteriorated

Infiltration: ☐ None ☐ Joint ☐ Cracks ☒ **Mortar** ☐ Roots ☐ Wall

missing mortar causing chimney infiltration

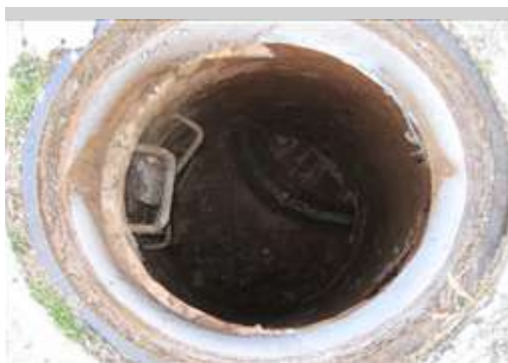
Defect 3

Frame Offset: **1** (in.) Condition: ☒ Sound ☐ Cracked ☐ Leaks

frame offset

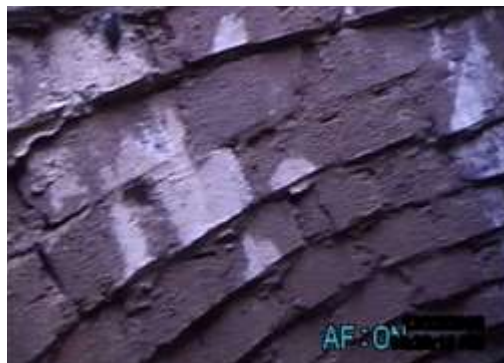
Defect 2

Infiltration: ☐ None ☐ Joint ☐ Cracks ☐ Mortar ☐ Roots ☒ **Wall**

corbel infiltration

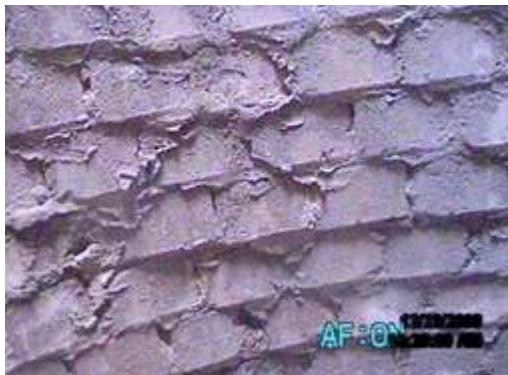
Defect 1

Infiltration: ☐ None ☐ Joint ☐ Cracks ☐ Mortar ☐ Roots ☒ **Wall**

barrel infiltration

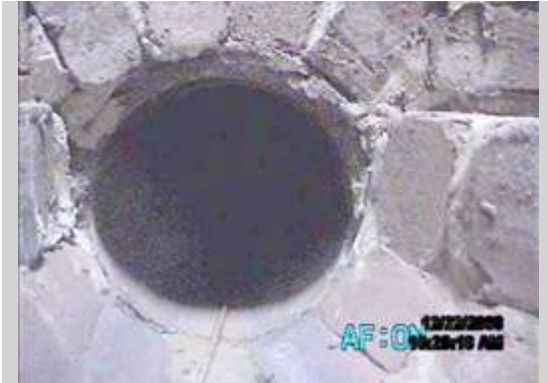
12 O'Clock Outflow

8 in. Circular Gravity Sewer
Pipe Out @ 12 O'Clock

Infiltration: **None** Pipe Seal Cond: **Sound**

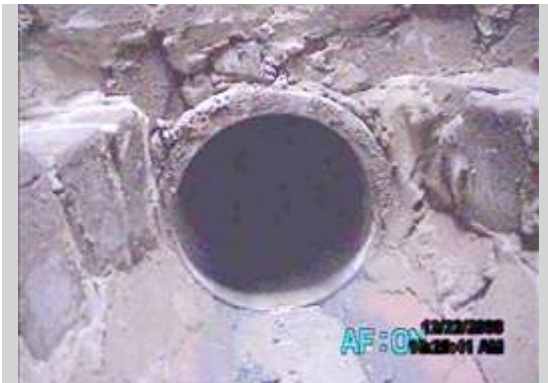
3 O'Clock Inflow

6 in. Circular Gravity Sewer
Pipe In @ 3 O'Clock

Infiltration: **None** Pipe Seal Cond: **Sound**
